BIOCORROSION IN THE MINING INDUSTRY ... BIG TANKS AND BIG PIPES

P. A Farinha¹

¹Extrin Consultants, Perth

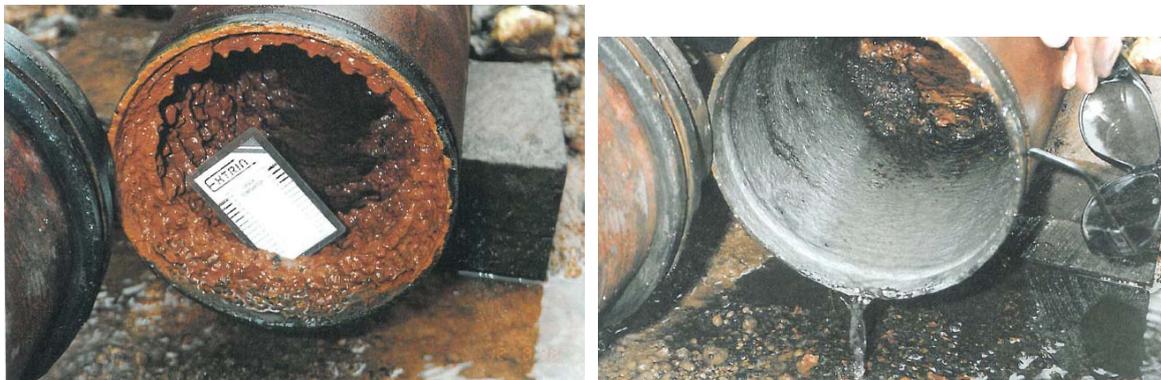
The internal pipe surface of the line had accumulated corrosion product/debris on the internal surfaces extending some 20 - 30mm from the internal surface and consisted of reddish brown tubercle growths with an underlying black deposit. Removal of the material for inspection of the parent pipe spool revealed a smoothly pitted substrate of bright, shiny appearance. This led to the sampling of accumulated material for further analytical testing

The neat samples were cultured and tested for SRB, iron bacteria and total bacterial present using recommended culture media after 21 days incubation at 30 degrees C. The predominant causative species appeared to be the SRB which were attached to the particles of corrosion product and there was a motile or planktonic count 1000 cells/ml, as well as *Gallionella* (the Iron bacteria) count was 300,000 cells/ml and the total bacterial count was 400,000 cells/ml.

Fig.1 A/B – Condition of the HDG pipe on opening and after removal of tubercles

Ultimately, the intake position of the pump was raised to a higher more oxygenated level and a water treatment (biocide) facility was installed at the pump inlet

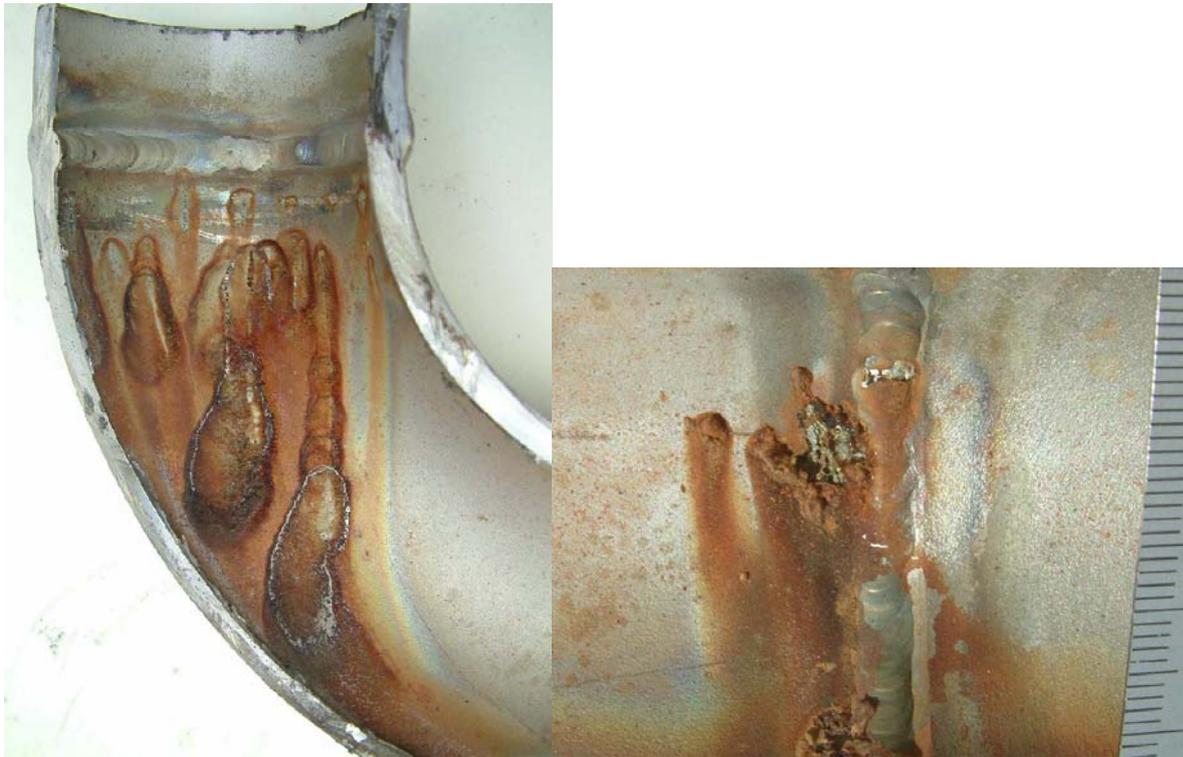
The pitting corrosion at the pipe work bore was consistent with microbiologically induced corrosion (MIC) as indicated by the significant build up of deposit on the internal surfaces, characteristic of bio-mound type formation, heavily undercut pitting with only small surface openings and subsurface, longitudinally oriented attack.

SEM analysis of the corrosion product identified the presence of sulphur, which along with the positive response to the presence of sulphate reducing bacteria (SRB) and *Gallionella* indicating MIC as a possibility. The corrosion product analysis also gave a small proportion of chloride, the presence of which was also considered likely to have contributed to the localised attack. The tubercles of *Gallionella* (iron reducing bacteria) are known to be a potential causative agents in the corrosion of stainless steel water piping systems, particularly in combination with the SRB.

Fig 2A/B – General and close up view of 304 stainless steel piping in a Reverse Osmosis piping and general view of the reddish brown tubercle location on the pipe inside surface at the pipe to tee weld.

In this situation, the 304L stainless steel was changed out, better attention to welding consumables occurred and the RO system performance has been good.

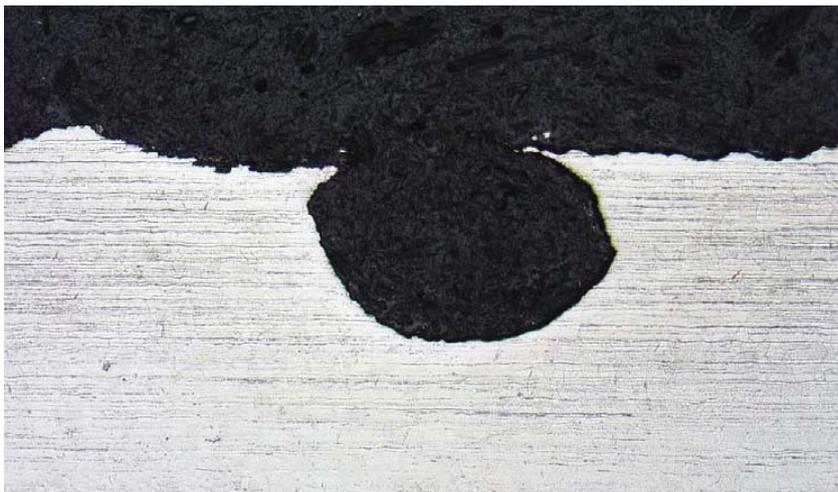
Fig. 2C – General view of the pit morphology under magnification (x100) at the pipe bore, with the narrow opening and smooth, rounded internal surface..

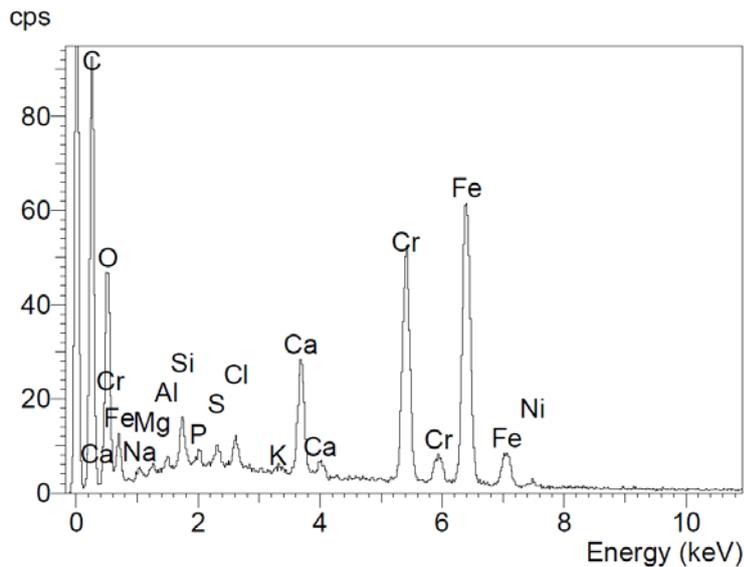
Fig. 2D - EDS analysis results of the corrosion product within one of the areas of pitting.

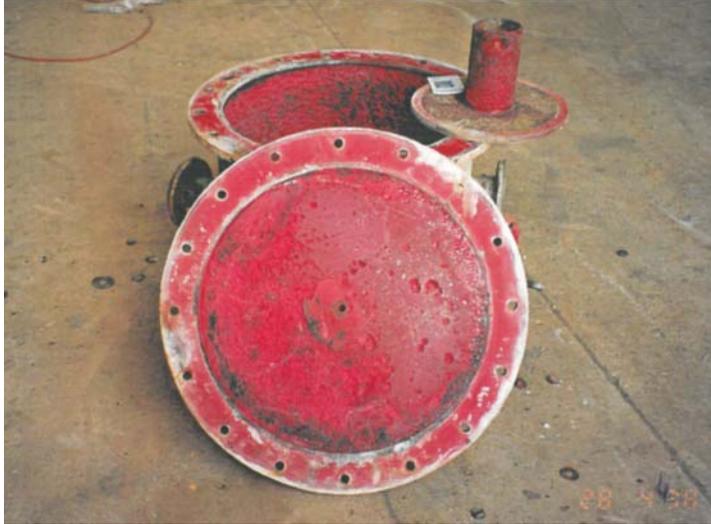
The rubber was 5 mm thick with an uneven surface on the side that had been exposed to the water. This surface contained craters or hollows. The deterioration appeared to be a localised loss of material varying in size from 5 - 25mm in diameter and extended to a depth of 10mm at worst. The general appearance of the rubber was dimpled, and it was not clear if the deterioration was limited to low velocity areas only. Ultimately, the rubber was being removed from the underlying steel substrate and colonisation by the SRB proceeded, with localised corrosion and perforation of the steel substrate resulting. The deterioration was extensive, and affected most

Specific microbial testing was performed on both rubber and water samples removed from site. Based upon the initial microbial test results, it was determined that the deterioration in the rubber was due to microorganisms.

Fig 3A – General view of rubber lined Cyclone cover, badly affected by deterioration of the natural rubber lining used for internal protection.

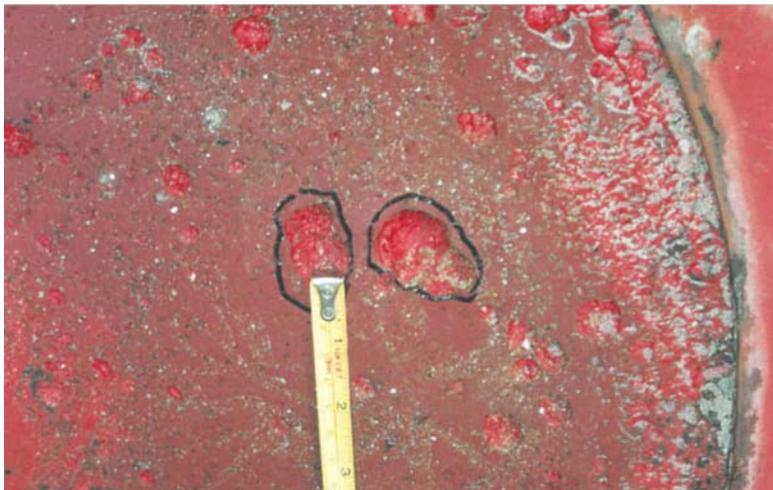
Fig 3B – Close up of the rubber lined Cyclone cover, showing the “pitting” as the rubber deteriorated, prior to the exposure of the underlying steel and the MIC associated with the substrate steel.

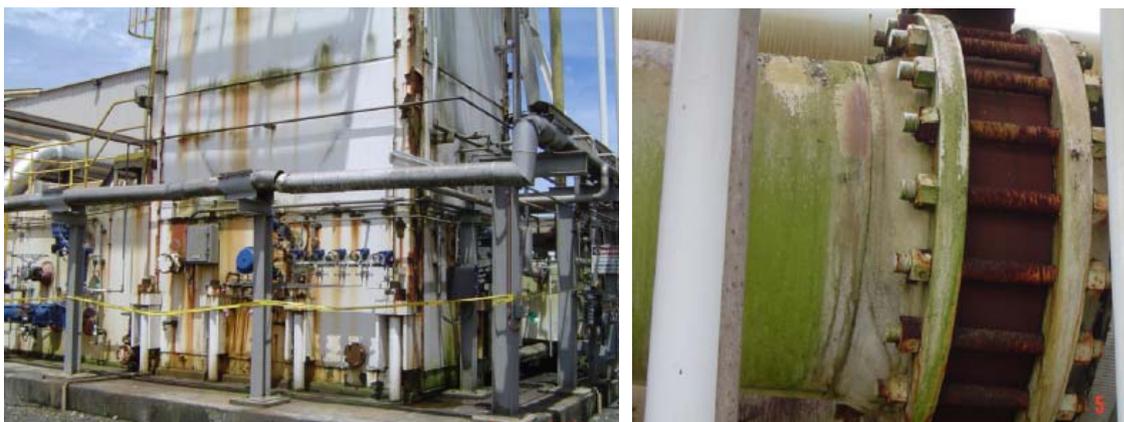
Fig 4 A/B – Algal growth over the high build epoxy on an Oxygen plant cooling tower, including the piping.

The predominant causative agent in this case was an algae which could not be specifically identified when examined. The situation was rectified by the use of high pressure water blasted with grit injection on the more extensively corroded areas accessed and the application of a algaecide loaded high build epoxy coating system for use on the entire cooling tower section.
