COATING DETERIORATION AND CORROSION MECHANISMS IN LEACHING AND ADSORPTION TANKS IN GOLD MINING

G. Harrison¹, W. Gray¹, P. Farinha¹, M. Risbud²
¹ Extrin, Western Australia
² Curtin University, Western Australia

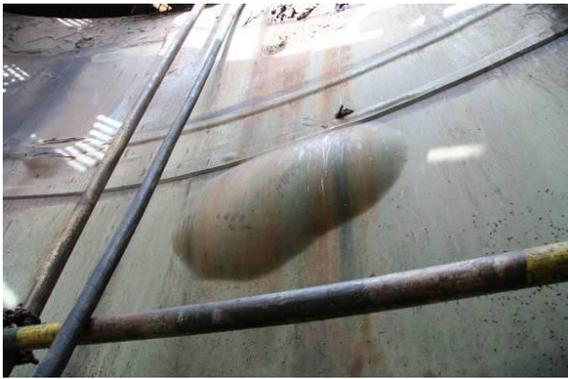
Osmotic blisters contain moisture which is suggestive of soluble contamination or moisture being present on the metal surface at the time of coating application. The mechanism that causes osmotic blistering is the same irrespective of the product. Osmotic blistering requires the following: (1) a permeable film; (2) a relatively impermeable substrate; (3) water dissolved solids; and (4) a concentration gradient [7]. The concentration gradient is the driving force for the creation and expansion of a blister. Osmotic blistering has been related to chlorides, sulphates, and other inorganic soluble species often found on substrates.

Figure 1 - Example of an osmotic blister and subsequent underfilm adhesion failure

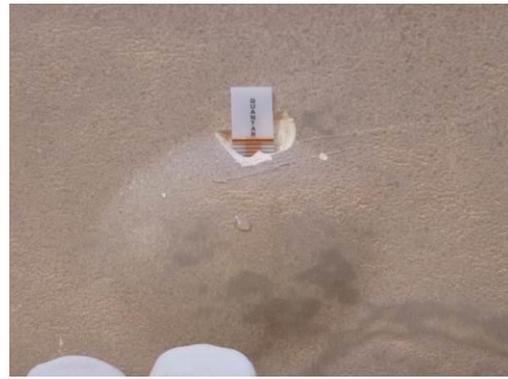
Figure 2 - Osmotic blister opened for analytical testing (Fe²⁺, Cl⁻, pH)

A selection of blisters were measured in two tanks that exhibited suspected osmotic blisters. In-situ tests for contamination were carried out on selected blisters, using blisters that were intact. In most cases, chloride levels in the blister solution were high, but corrosion, and therefore soluble iron salts, were only found under those blisters that were between the coating and the steel substrate. The results of the intercoat blisters showed that the blisters had a pH of between 5-7 but varying chlorides 155-650ppm suggesting that chlorides were left on the surface of the first coat before application of the second coat of the coating product. It should be noted that osmotic gradients may arise from corrosion products such as Fe(OH)₂ and where chlorides and sulphates are simultaneously present, the corrosion products are even more soluble in water. Blistering can generally be reduced or eliminated by correct substrate surface preparation and proper selection of coatings materials.

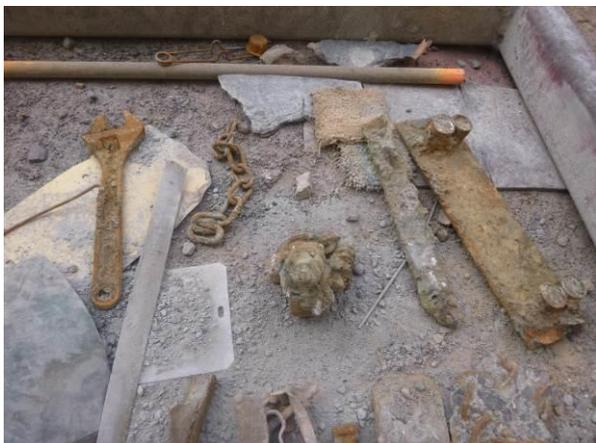
One of the most prevalent causes of coating mechanical damage is dropped objects in the tank. The agitated slurry in the tank pushes the items around, striking and causing damage to the coating at the point of impact. If the coating is robust enough to withstand the impact there is little or no consequence however, 16% of the tanks in the survey showed that mechanical damage due to item impact was the primary reason for coating breakdown and subsequent corrosion. Figure 5 shows some examples of items that have been dropped into the operating tank caused damage to internal coatings.

Figure 3 – Various items that have been removed from inside of a tank once drained. Larger items such as an interstage screen and agitator blades have been known

to be found in the bottom of the tanks.

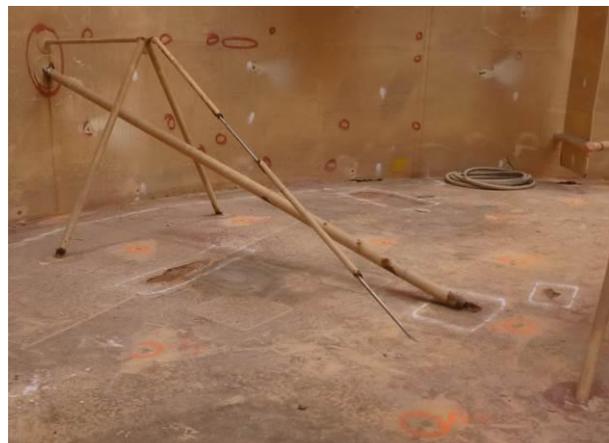
Figure 4 – A failed oxygen sparge has made contact with the floor and through movement caused by the agitation of the slurry is mechanically removing the coating on the

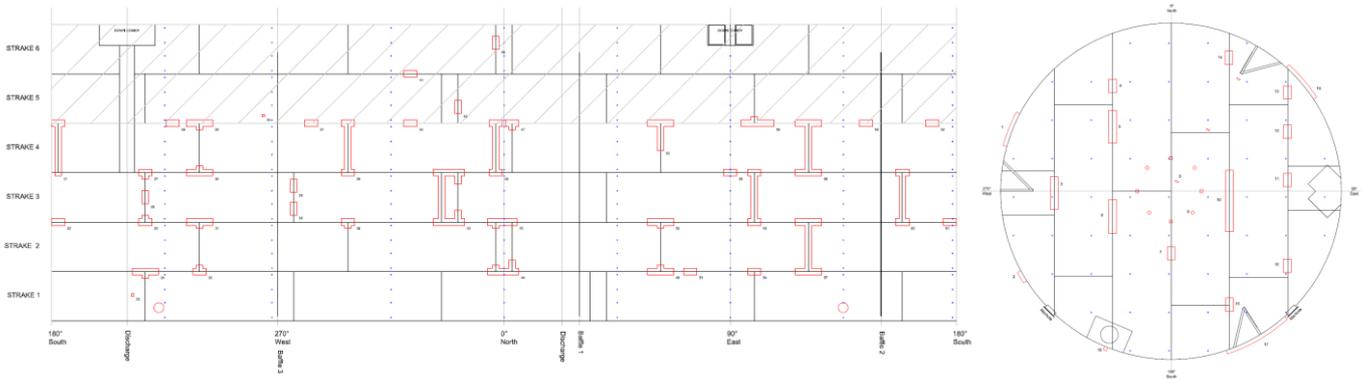
Figure 5 and 6 – Example of typical wall elevation (left) and floor plan (right) showing coating breakdown measurements

Data from 42 tanks showed coating breakdown factors of between 0% - 38% with an average of 4% at the time of inspection. This equates to 30-60m² of unprotected steel.

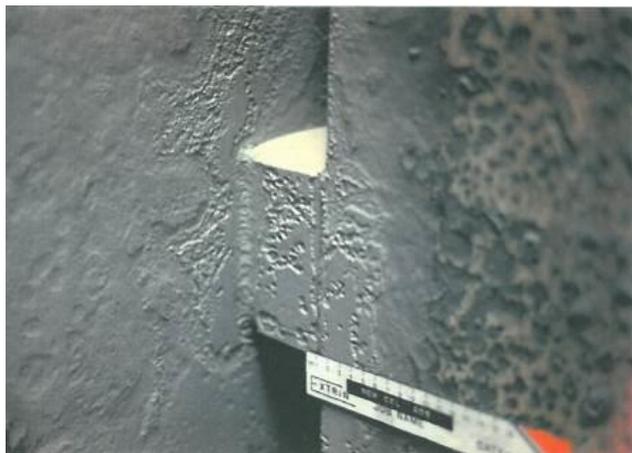
Figure 7 – View shows minor pitting in an area of increased velocity close to a baffle support. Image was taken after abrasive cleaning

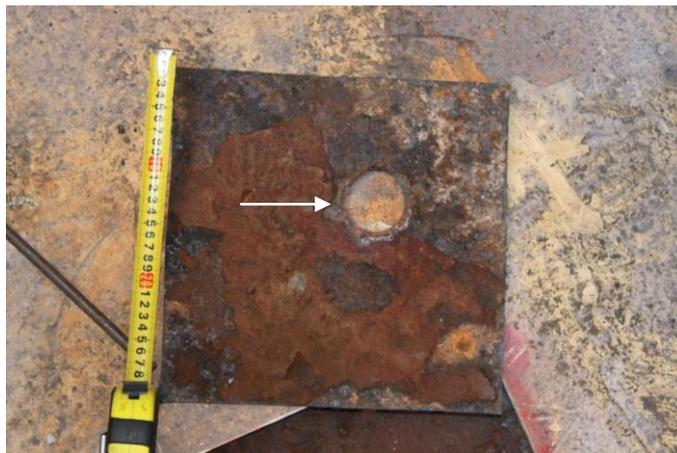
Figure 8 – 300mm x 300mm plate cut from tank floor to ascertain if the perforation (white arrow) was due to corrosion from the underfloor environment

As part of an investigation into perforation in tank floors, on six various sites, 300 x 300mm plates (figure 8) were cut from the tank floor that included a perforation. These were used to determine if localised corrosion was also occurring from the outside/in, or if the corrosion risk was predominantly from the inside/out. The samples were retained for testing and results showed that 60% of the plates showed corrosion from the inside/out with the remainder being from the outside/in.

Further investigation into the high instance of outside/in perforation of the plates was carried out in the form of soil/backfill testing underneath the tanks in the area cut out. Resistivity testing of the compacted sand tank base materials was performed using a Wenner 4 pin procedure and a soil resistivity determined of 140-180 Ω -cm. This value is considered an extremely low resistivity (a high conductivity) and suggests the floor backfill material has a severe corrosivity rating. Should moisture penetration/saturation in the tank ring beam backfill increase, the corrosion risk from the outside/in would increase and this would require careful corrosion management consideration.

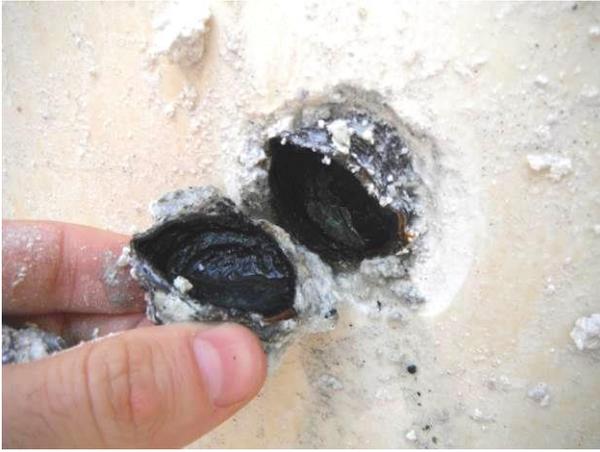
Figure 9 – Stereotypical MIC tubercle formation on the inside of a tank

It has been demonstrated that microbial corrosion occurs in a leaching and adsorption tank circuit, in those areas under deposits and tubercles where anaerobic conditions can exist. This is particularly the case when sulphidic mineral ores are being processed.

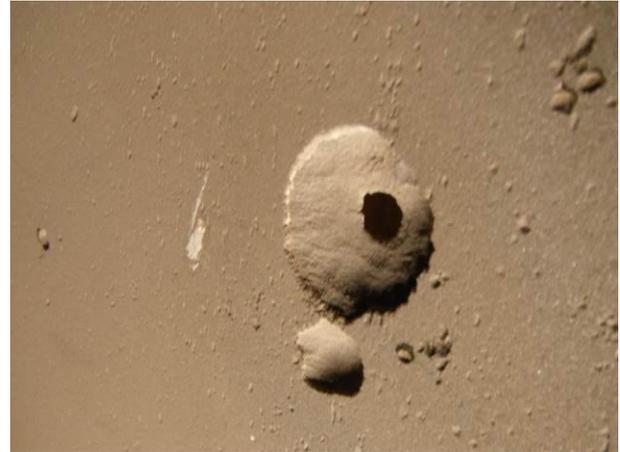
Figure 10 - MIC damage evident underneath tubercle. Image was taken after abrasive cleaning

As the images above show, the morphology of attack associated with SRB (pitting corrosion) is such that a substrate can be perforated in several locations with the parent plate immediately adjacent in good condition. This makes MIC difficult to provide accurate corrosion rates that can be utilised to determine the time to perforation. Steel corrosion rates of 5-10mm per annum have been recorded under these circumstances.

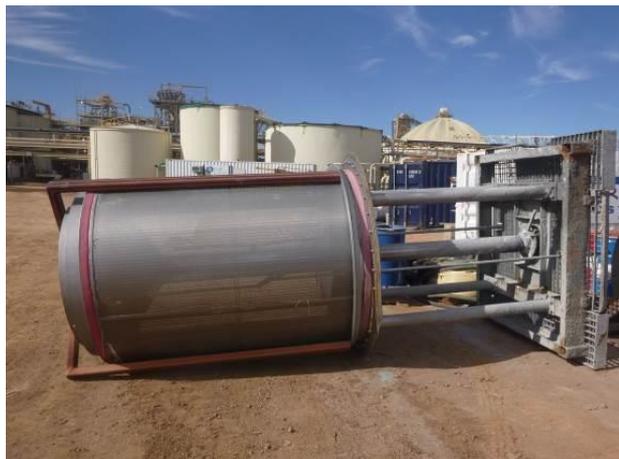
Numerous steel repair patches were observed on the coated carbon steel tank, in close proximity to the screen. Excessive localised corrosion on the uncoated carbon steel tank and interstage screen frame near the interface with the stainless is most likely due to galvanically accelerated corrosion in the very conductive tank environment. On closer inspection of the tanks in which this was observed, the tank and the inter-stage screen were not electrically isolated.

The total surface area of the Stainless Steel wedge wire screen and rotating cage assembly was calculated at about 43m². The corrosion current calculated based on this surface area equates to approximately 5.6A. According to Faraday's Law, the amount of the material corroded in an anodic reaction or deposited in a cathodic reaction is directly proportional to the quantity of electricity passed. Assuming a break or a holiday in the tank's coating system exists, a corrosion current of 5.6A would provide sufficient driving force for about 51kg of material loss per year from the tank wall. Put in these terms it becomes apparent why

Figure 11 –Stainless steel carbon transfer screen

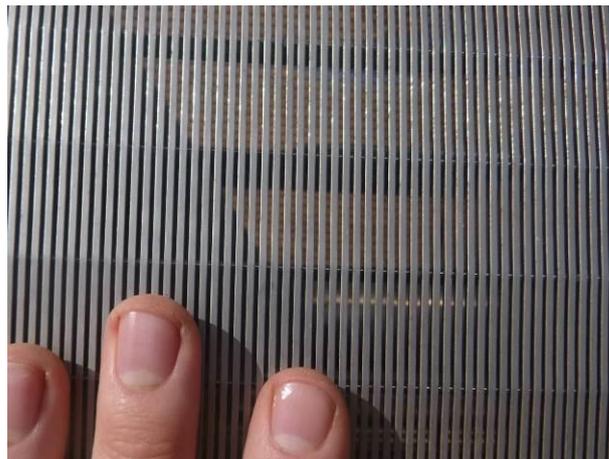
Figure 12 – Detail showing large surface areas

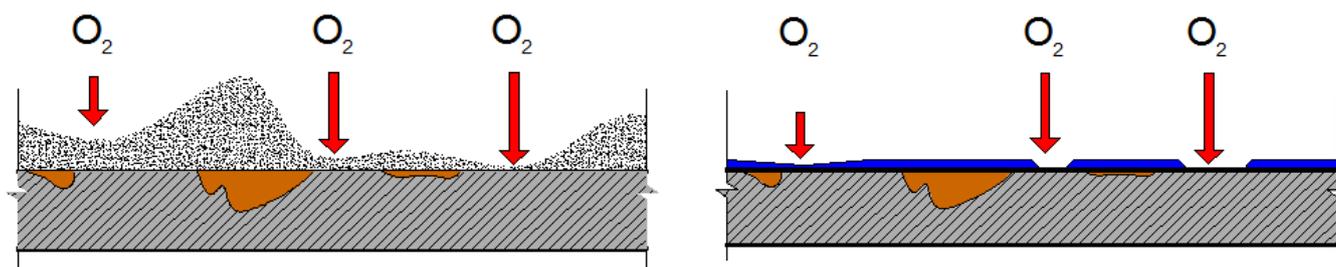
Figure 13 – Differential aeration corrosion diagram

As seen in Figure 13, at locations where less oxygen can penetrate the coating in comparison with the surrounding areas, an anodic site will be formed and localised metal loss will occur. Areas with lower or no debris collection will have better access to oxygen, and these areas will be cathodic, thus driving the corrosion cell. Hence the debris collection facilitates the formation of differential aeration cells.
